# **Gay Head Light Station Martha's Vineyard, Massachusetts**

UNITED STATES COAST GUARD, FIRST DISTRICT  
LIGHTHOUSE PROTECTION STUDIES, NEW ENGLAND

GAY HEAD LIGHT STATION  
MARTHA'S VINEYARD, MASSACHUSETTS

AUGUST 1989

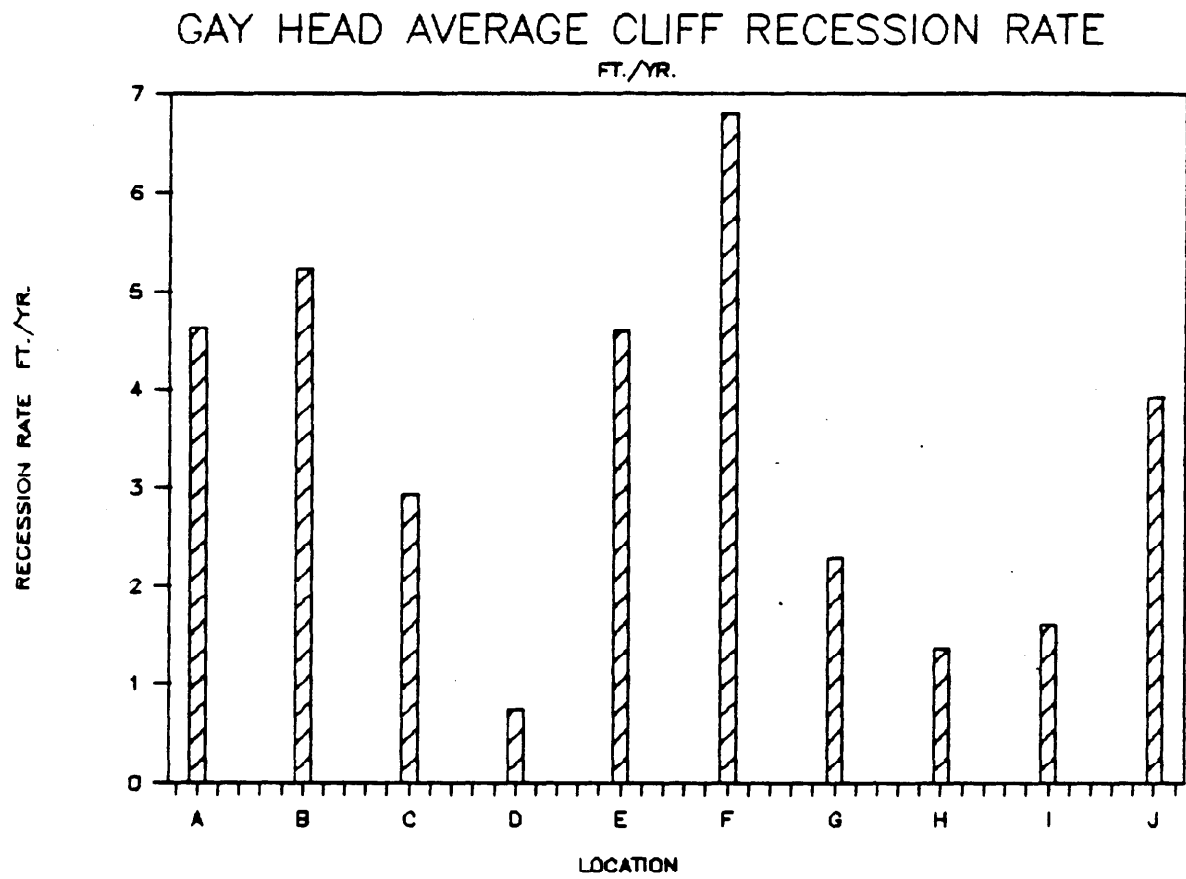
FIGURE 1

Table 2 was derived from Table 1 and shows the average rate of recession for each location for those years where data was available. The overall average annual rates of cliff recession, derived from data gained from the sources listed above and presented in Tables 1 and 2, are displayed in Table 3. The same rates are shown graphically in Figures 1 through 4. Figure 1 shows the average annual cliff recession rates for locations A thru J. Figures 2 thru 4 show cliff recession rates for stations G, H, and I which are immediately adjacent to and inclusive of the lighthouse property.

Location	Average Annual Recession Rate (feet/year)
A	4.6
B	5.2
C	2.9
D	0.74
E	4.6
F	6.8
G	2.3
H	1.4
I	1.6
J	3.9

**Average overall annual recession rate is 3.4 feet/year**

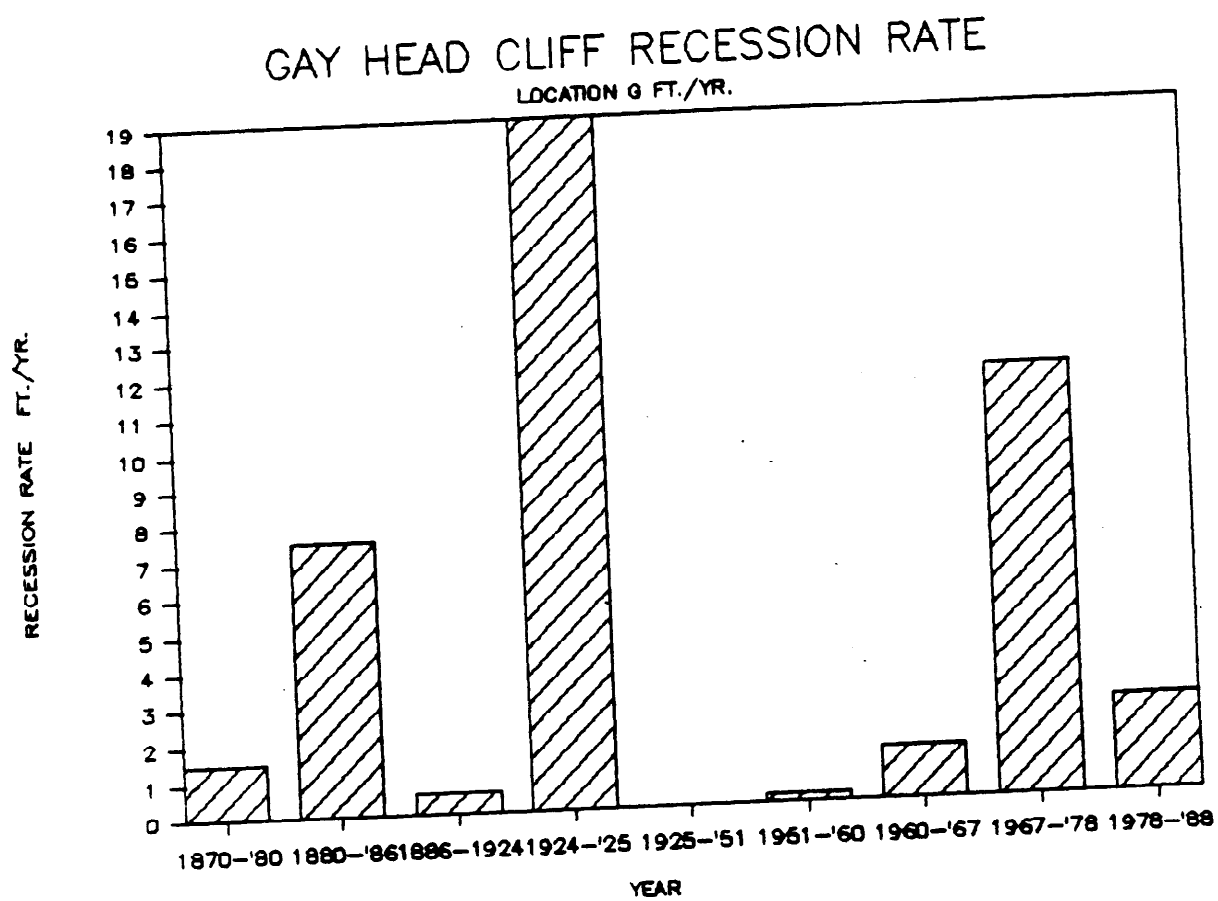
FIGURE 2

such as landslides which occur infrequently as compared to a steady rate of erosion. Some of the higher values in Table 2 probably reflect the effects of localized landslides. Another good example of this variability in rates of erosion is the recession rate at location G, the northern property line of the lighthouse lot. Here it varies from 19 ft/yr (1924 to 1925) to 0 ft/yr for the next 26 years (1925 to 1951).

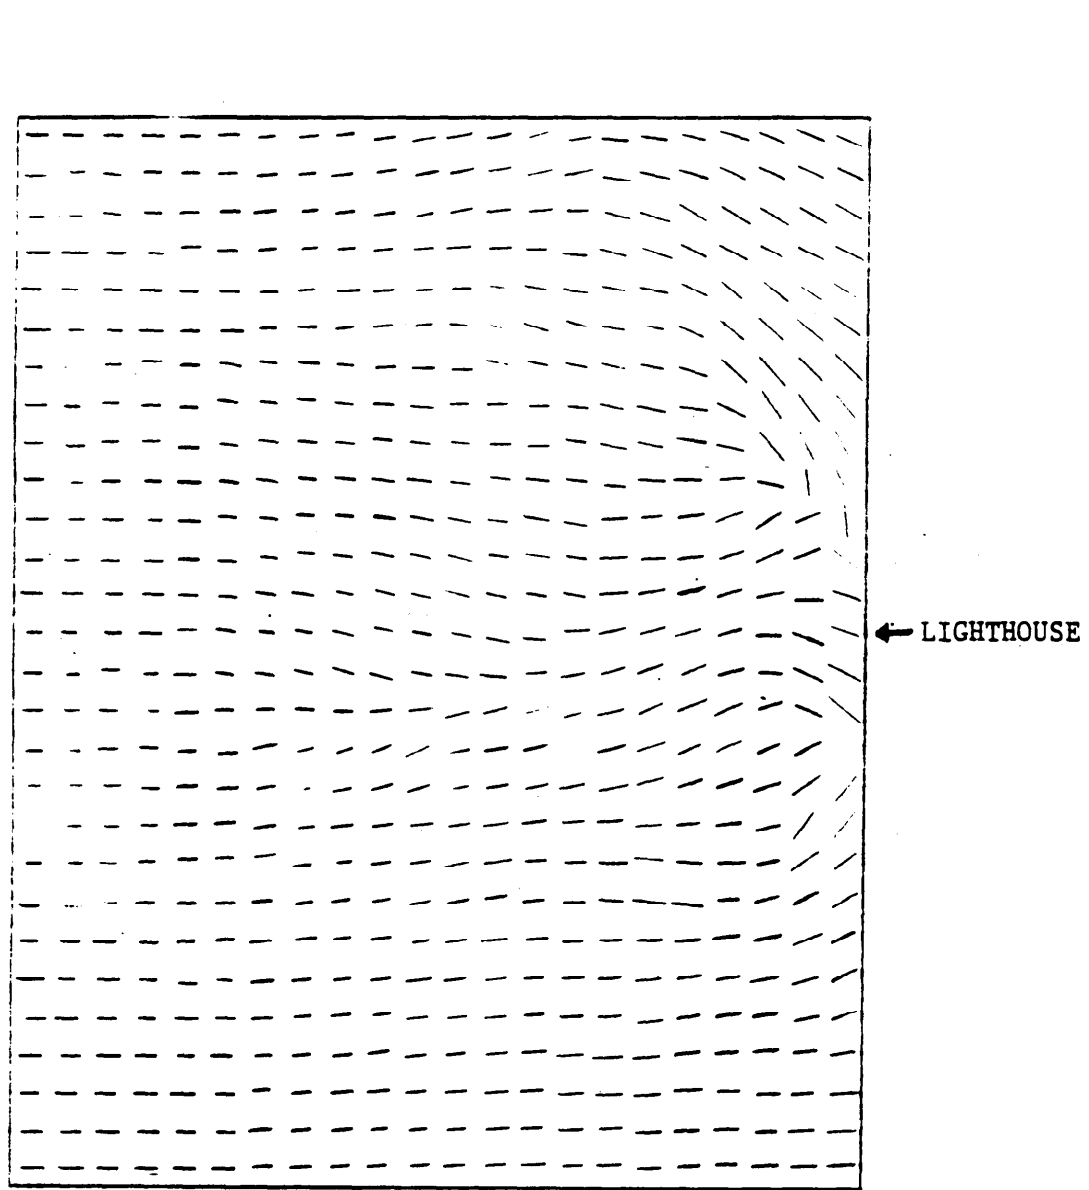
FIGURE 6

Using RCPWAVE data, waves from different directions were used in an analysis of wave angles as they approach the shore. Figures 6 and 7, plot the angle the waves make with the shore at grid points. This is not a ray trace, it shows wave angle but not areas of energy concentration. Data for these plots were generated by RCPWAVE and plotted by hand. Because of the variability of the bottom topography and the lack of complete data, the results are not definitive. However it is clear in all plots that wave angles are refracted near the area of the lighthouse. Although no data for energy concentration was available, it is reasonable to infer that the patterns of wave refraction noted are indicative of areas of energy concentration at the base of the cliffs near the Gay Head Lighthouse. As such they underscore the vulnerability of the cliffs to wave undercutting and recession in the vicinity of the lighthouse.

RCPWAVE WAVE ANGLES FROM WEST

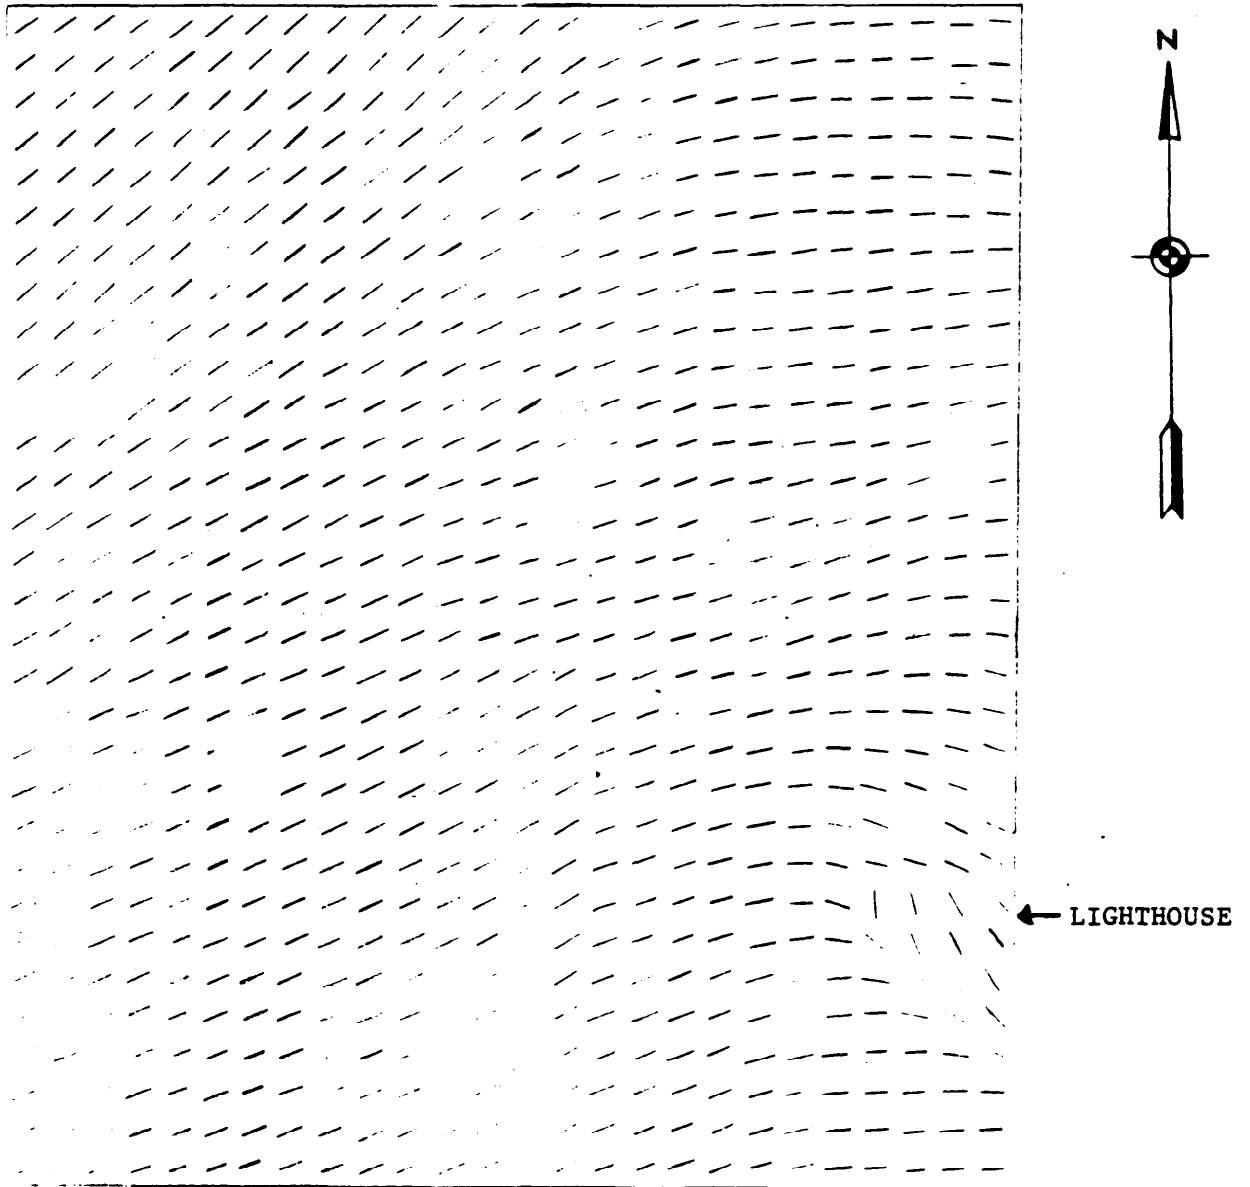
FIGURE 7

RCPWAVE WAVE ANGLES FROM SOUTHWEST

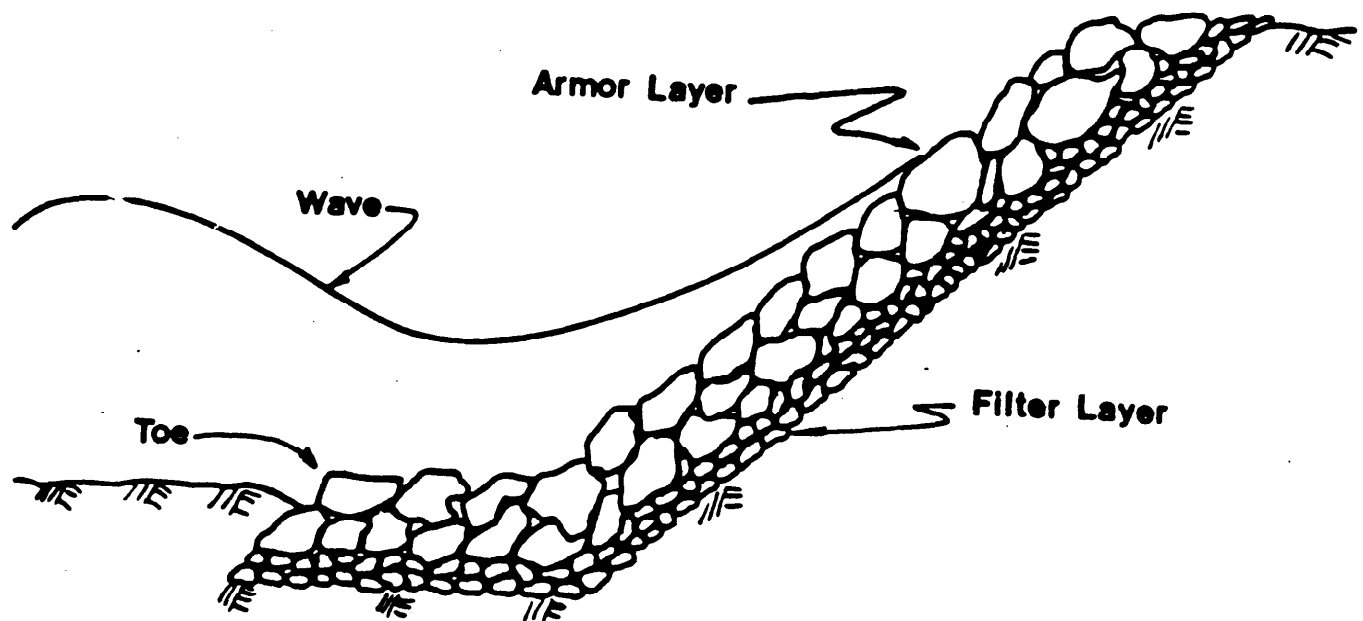
FIGURE 8 - TYPICAL REVETMENT SECTION

A detailed plan of a revetment suitable for the protection of Gay Head Light is beyond the scope of this report. For illustrative purposes, however, a typical cross section of a revetment is seen in Figure 8. An analysis of the situation, suitable for general planning purposes only, supplies the following design data.

- a) deep water wave height (from SEAS data) of 20 feet
- b) estimated vertical run-up on rough quarry stone of 16 feet
- c) revetment slope of 1.0 V on 1.5 H
- d) armor layer thickness of 15 feet  
underlayer thickness of 2 feet  
bedding layer thickness of 1 foot
- e) cross section of structure is 850 square feet
- f) linear dimension of 4,000 feet (length of Coast Guard property)
- g) volume of revetment using above dimensions is 3.4 million cubic feet. Assuming 25% voids and a rock density of 165 lbs/cu ft results in a weight of 210,000 tons
